Former Clifton MGP Site Operable Unit 2 Richmond County, New York

Construction Completion Report

NYSDEC Site Number: 2-43-023

AECOM Technical Services, Inc.

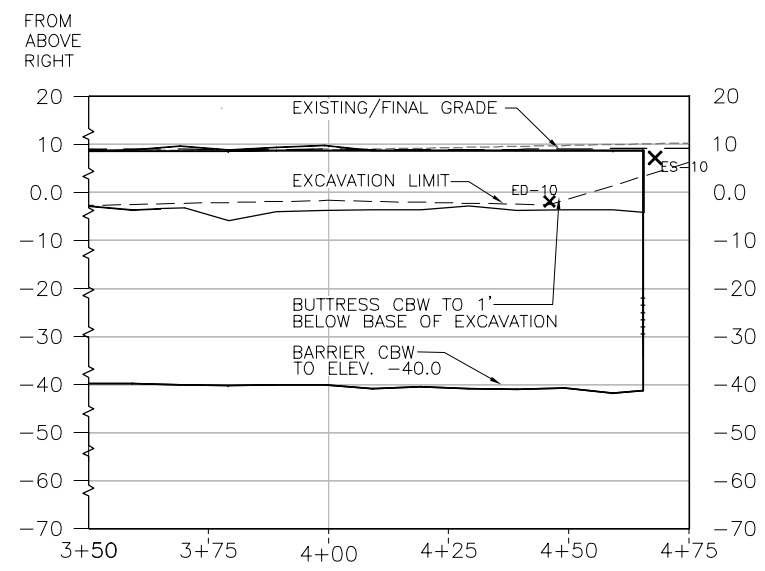
WILLOW AVENUE SCB SLURRY WALL PLAN AND PROFILE

File: V:\Clifton\60137363\CADD\CCR\FIGURE 4-5 SCB SLURRY WALL AS-BUILT CROSS SECTIONAL VIEW.dwg Layout: F 4-3 User: weix1 Plotted: Oct 30, 2013 - 3:27pm Xref's:

BAY STREET SCB SLURRY WALL PLAN AND PROFILE

A 650 feet long and 3 feet wide Slag Cement Bentonite (SCB) Slurry Wall was installed to a maximum depth of 50 feet bgs as the vertical barrier walls in two areas of the Site to prevent migration of DNAPL off the Site. The SCB Slurry Wall was also constructed as a buttress wall at the perimeter of the excavation area to provide excavation wall stability as well as reduce the amount of lateral groundwater infiltration into the excavations. The buttress wall was constructed by widening the SCB Slurry trench by an additional 6 feet to a depth of 13 feet bgs for total buttress wall dimensions of 9 feet wide and 13 feet deep.

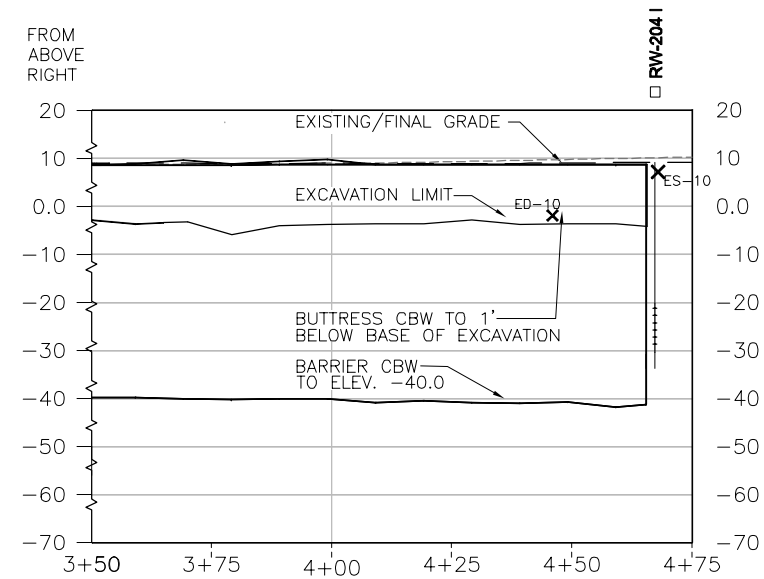
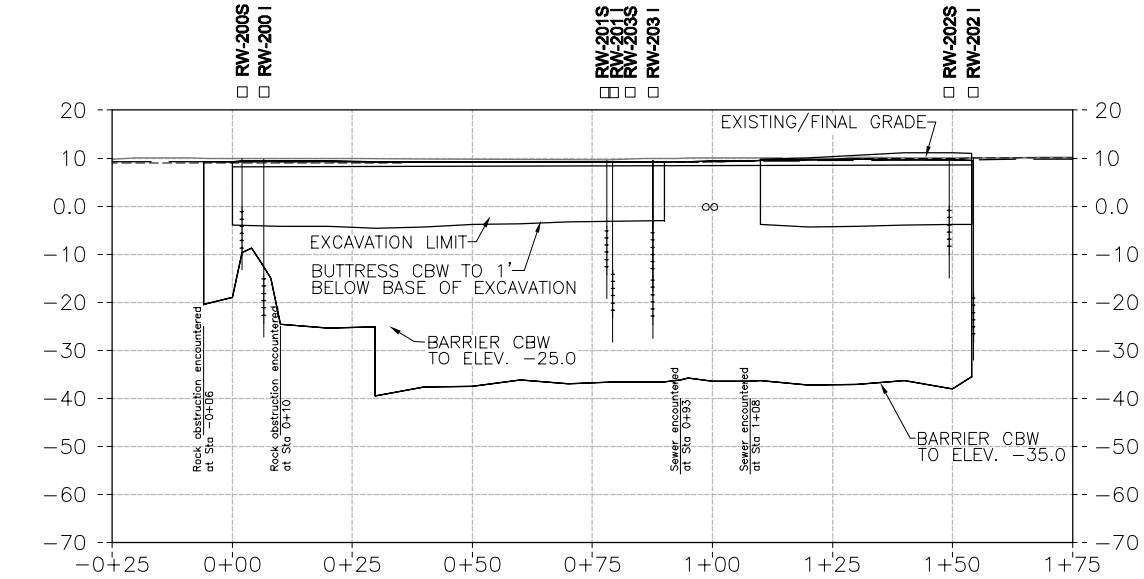
WILLOW AVENUE SCB SLURRY WALL PLAN AND PROFILE

File: V:\Clifton\60137363\CADD\CCR\FIGURE 10 DNAPL RECOVERY WELL CROSS-SECTION VIEW.dwg Layout: F 4-3 User: weix1 Plotted: Oct 30, 2013 - 3:35pm Xref's:

BAY STREET SCB SLURRY WALL PLAN AND PROFILE
